# BESPOKE FISHING & MILLING SOLUTION

Delivering on challenging P&A Operation for Slot Recovery

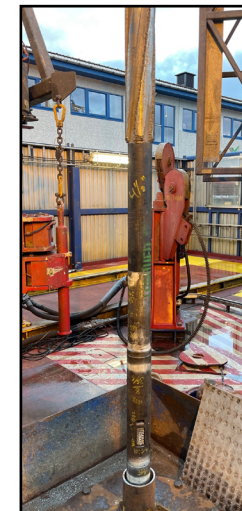
New 4 1/4" Cutter  
undergoing testing

- Extensive Pre-Job Planning alongside client
- New technology ~ 4 1/4" cutter & knives developed, built and tested
- Contingency plans & equipment ready to mobilise
- Collaborated with specialist suppliers to provide single source expertise
- Dual cut on 5" and 7" Liners ~ completed in 45 minutes
- Specially designed 7" Mill to mill out Liner Hanger
- Spear run to recover dual 5" and 7" Liners ~ 31 ton overpull to free

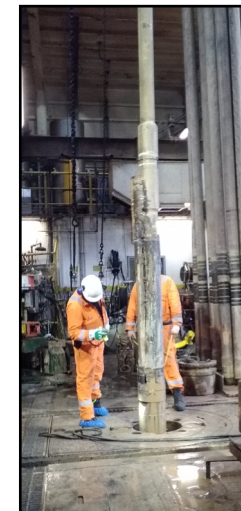
Dual 5" & 7" Liners  
recovered to surface

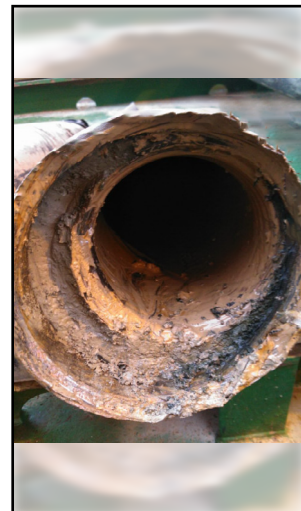
- Suspected collapse of the 7" Liner
- 5" Liner stuck inside 7" due to settled solids / barite

5" & 7" Liner with Settled  
Barite in Annulus
